Why Extract A Core Sample

All About Holes Ltd

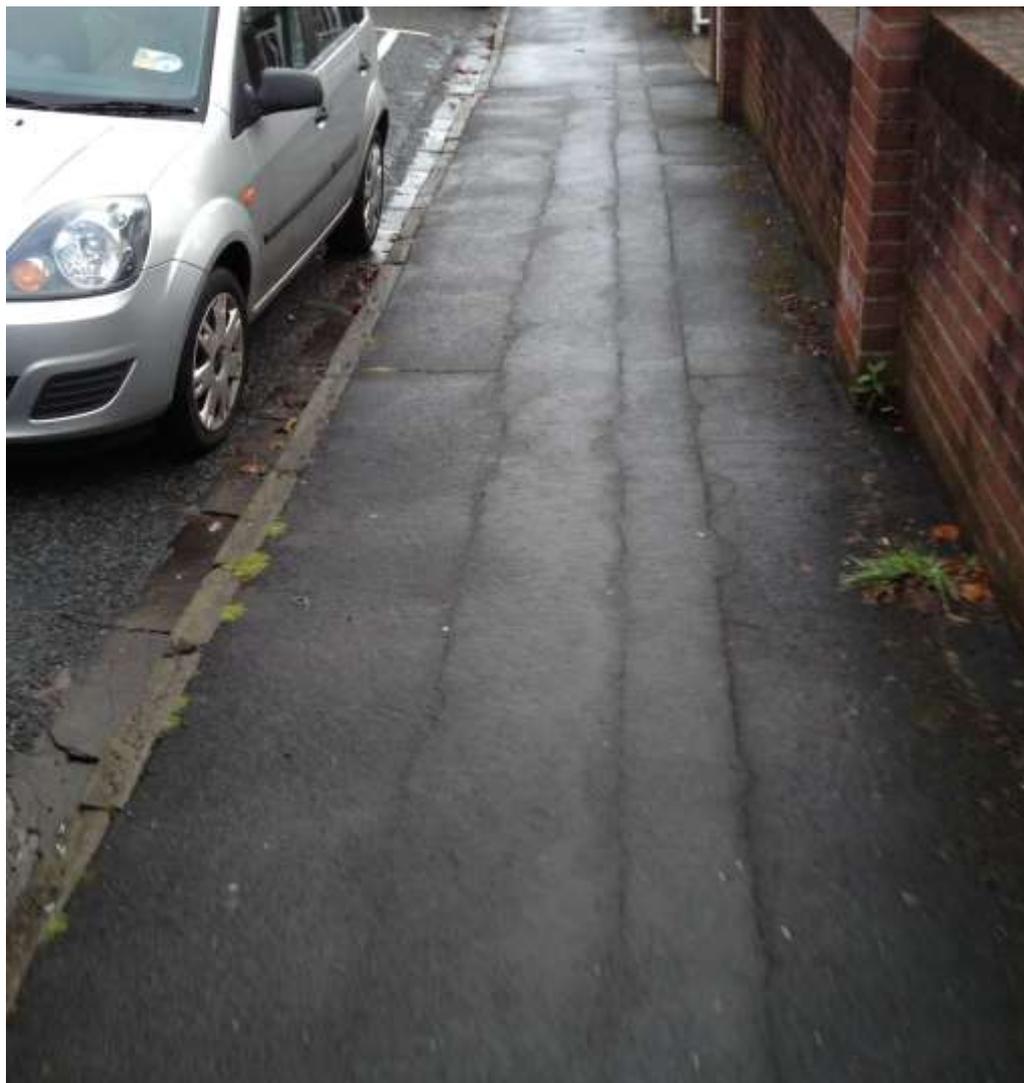
A footway that has been slurry sealed, within 12 months the utility trench below starts to break down, however the authority have now taken ownership of the footway – therefore how do you know how good the trenches are before they are covered up?

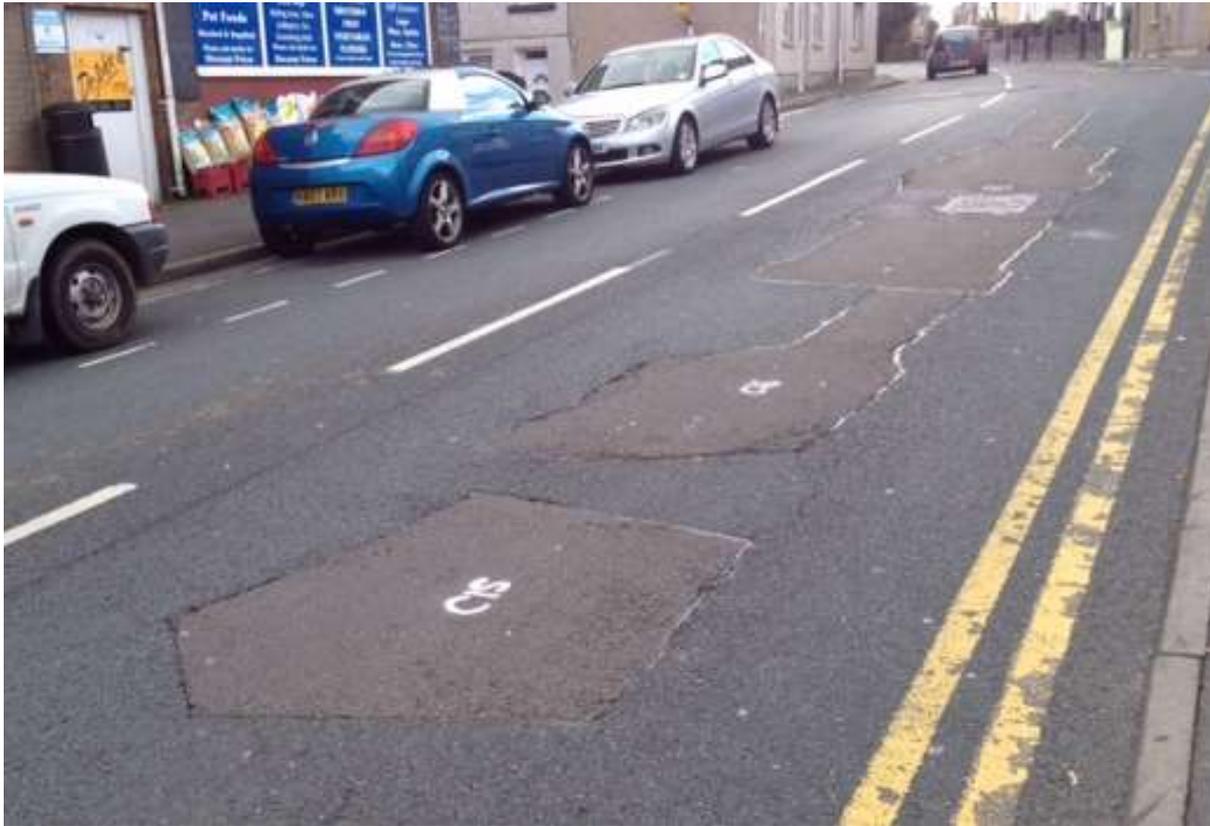
One side of the road is failing badly due to utility works, the other side is perfect, the works were undertaken in 2008 and therefore out of guarantee, the term contractor estimated a cost of over £60,000 to remedy this, therefore 28 core samples were undertaken and 27 failed to meet the specification, all on depth and mostly considerably less than 285mm, the utility company in question has now agreed to undertake all remedial works.

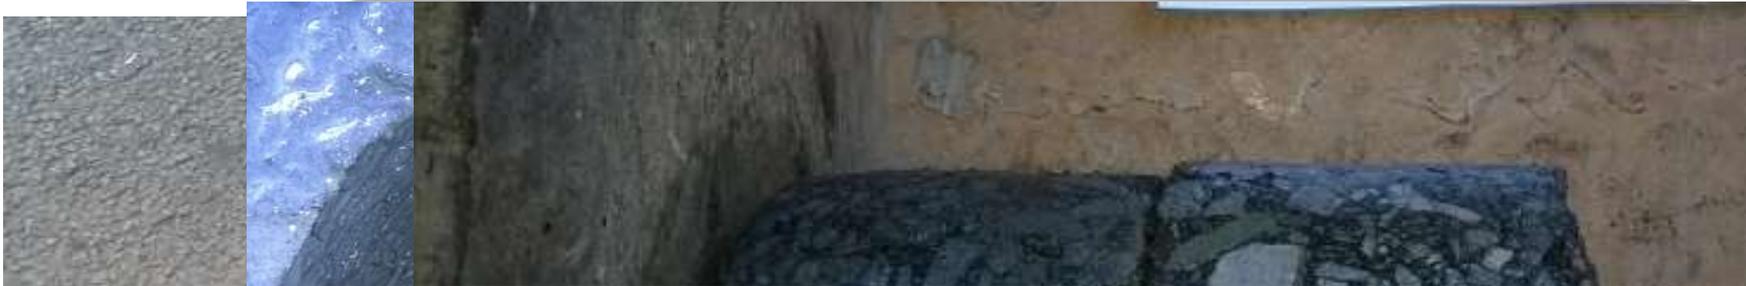
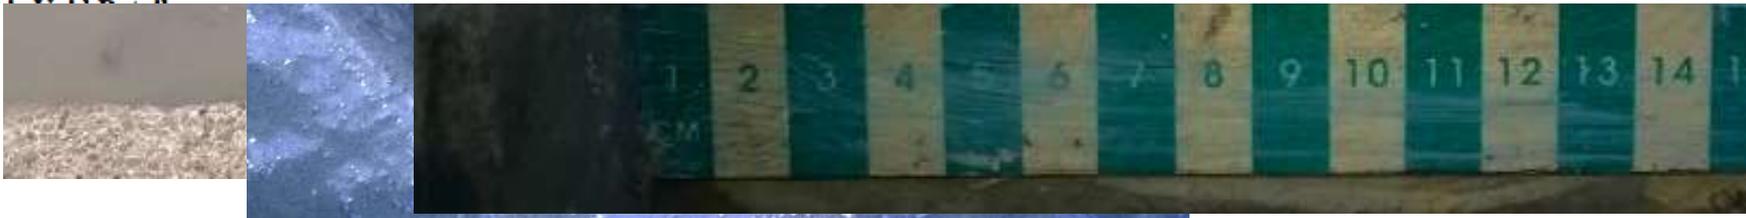
Insufficient Depth

Layer Course	Material and aggregate type	Structural Thickness (mm)				Overall Thickness (mm)			Air voids (%)			Remarks	
		Found				Min	Pass/Fail	Found	Min	Pass/Fail	Found		Min - Max
Surface Course	AC 10 Close Surface Course	61				35	PASS	126	285	FAIL			
		60	60	63	60								
Binder Course	AC Binder Course	65				235	FAIL						
		63	66	62	67								
Road Base Identified: Stone		Site Length	0.96 m	Site Width	0.76 m	Site Dimensions		0.7296 m ²	OVERALL RESULT			FAILED

A Type 2 road, that is 4 year old when the patch was showing signs of deterioration, frighteningly to date it is very rare that the correct depths are met on category 2 roads that we have tested.

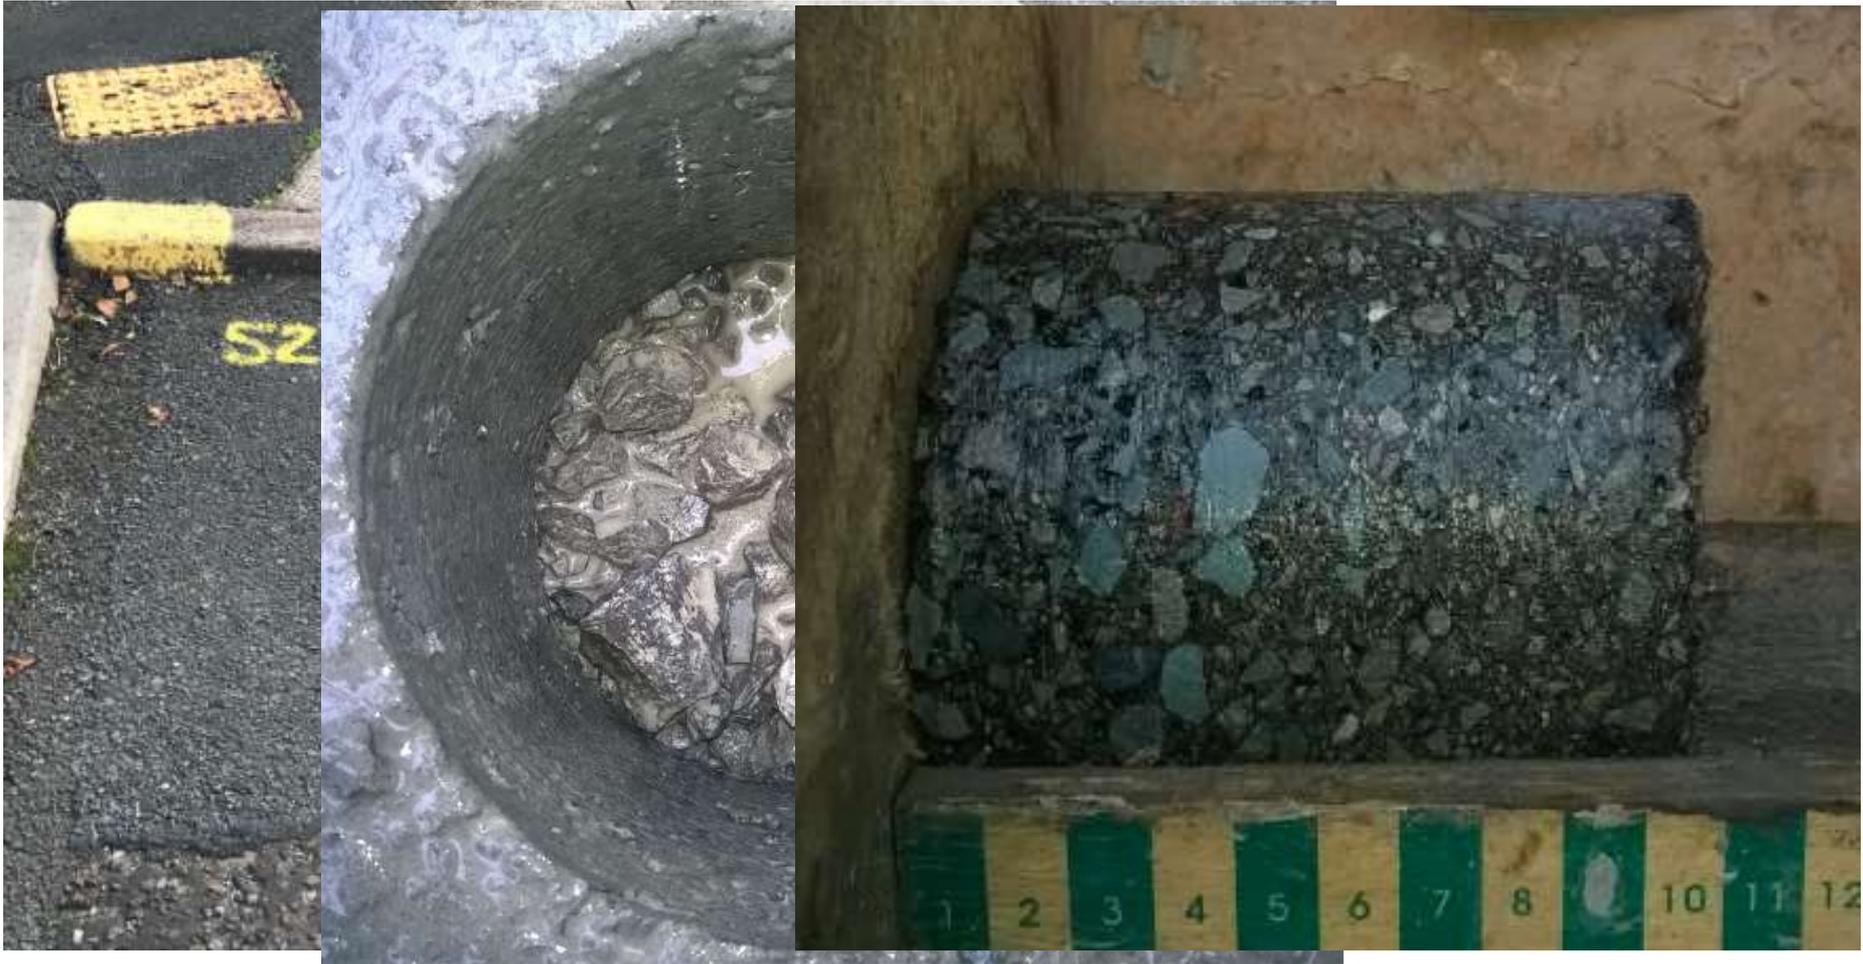
Incorrect Material

A 6mm binder course used within a carriageway, however a 10mm surface course used

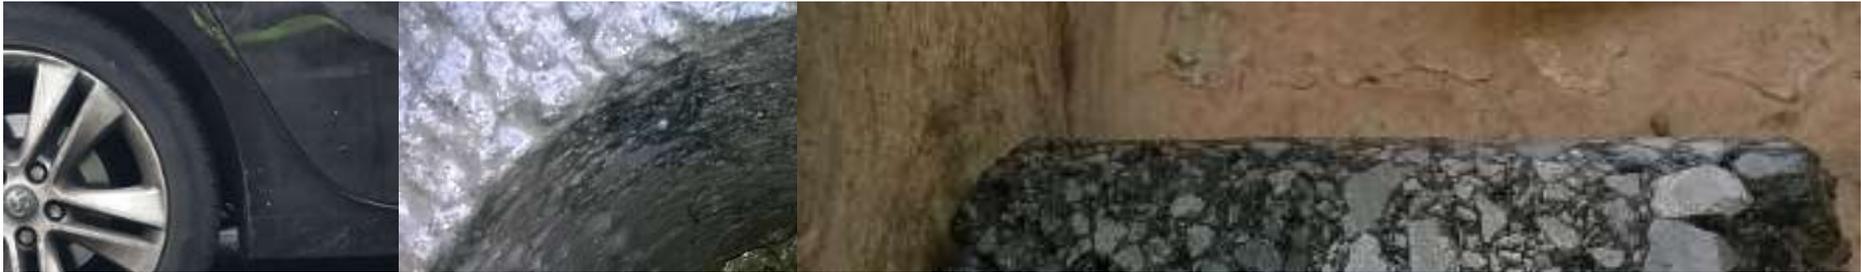
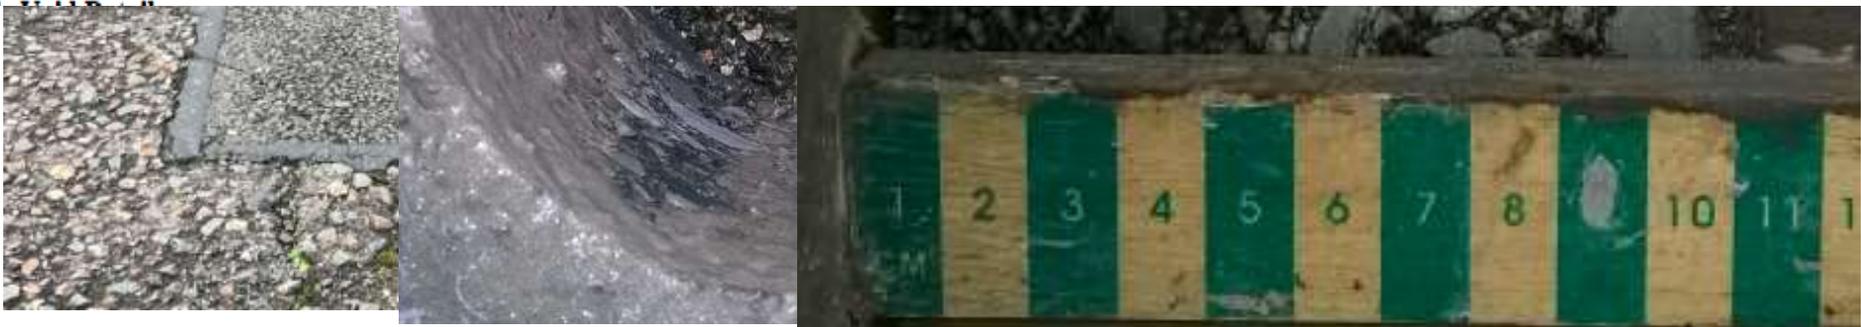
Excessive Air Void

Layer Course	Material and aggregate type	Structural Thickness (mm)				Overall Thickness (mm)			Air voids (%)			Remarks		
		Found				Min	Pass/Fail	Found	Min	Pass/Fail	Found		Min - Max	Pass/Fail
Surface Course	AC 10 Close Surface Course	43				35	PASS	101	100	PASS	19.2	2 - 10	FAIL	Failed by 8.7% S/C after tolerance has been applied - B/C passed.
		48	35	45	43									
Binder Course	AC Binder Course	58				50	PASS			PASS	9.8	2 - 10	PASS	
		55	64	51	62									
Road Base Identified: Recycled		Site Length 3.16 m		Site Width 0.5 m		Site Dimensions 1.58 m ²		OVERALL RESULT			FAILED

Was the material cold, incorrectly compacted or was there not enough fines within the mix?
